# Locke Estate Site 7

## Expression of Interest Information

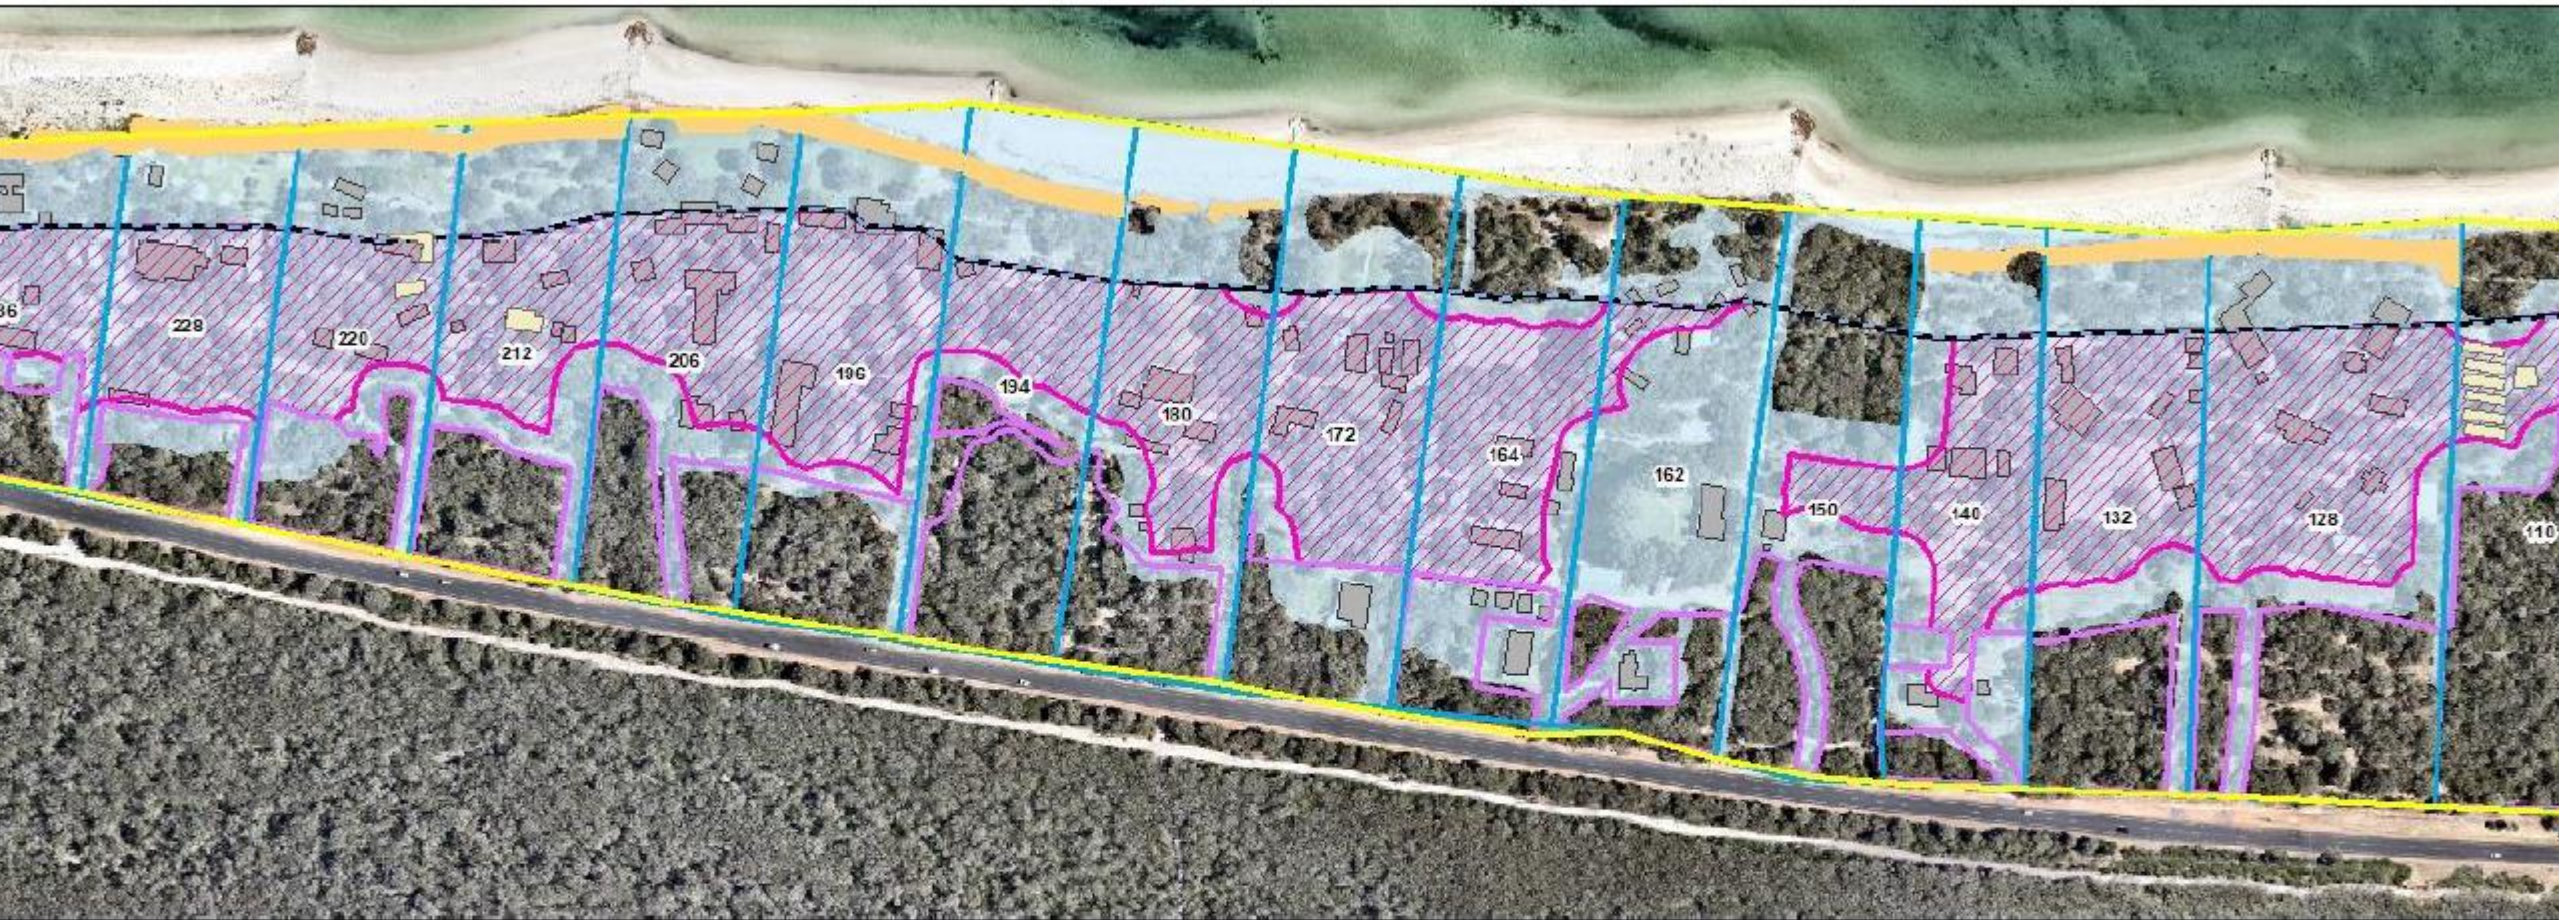
- Proposed building
- Lot Boundary
- Class D Scrub
- Sublot Boundaries
- Coastal Setback Zone
- Conservation Zone
- Developable Area
- Existing Buildings
- Low Fuel Zone

Buildings (potential exception of sheds) may only be constructed within the Developable Area which achieves BAL-29 and is outside the Coastal Setback and Conservation Zone with an approved or exempt clearing permit and fauna spotter where vegetation removal

The driveway access will comply with the requirements of the Guidelines (A3.5). Maintain any future obligations under the City of Busselton Firebreak

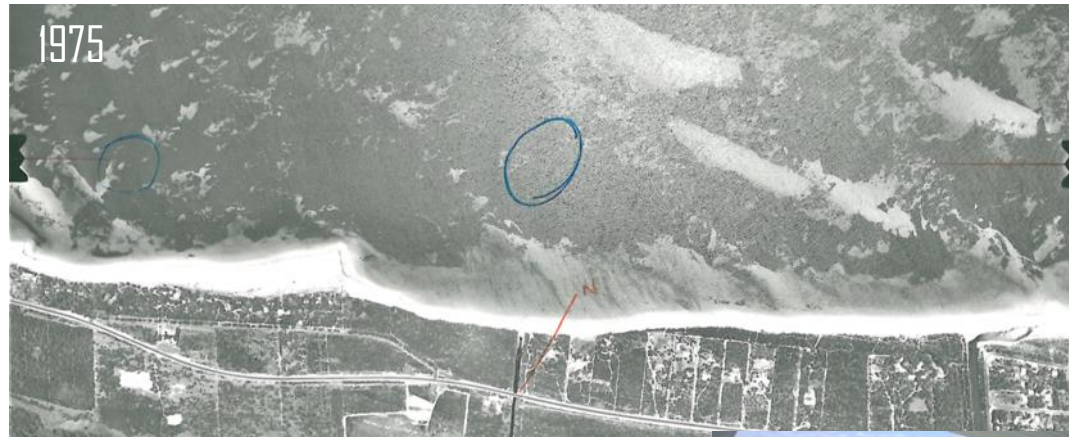
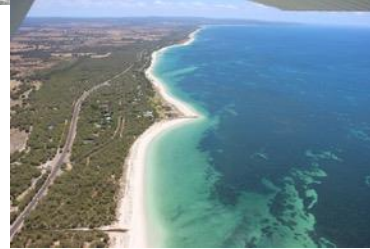
## Coastal Processes – Longshore Sediment Transport (Siesta Park Groyne)

Erosion at Locke Estate is 160m since 1941.

Direct influence extends ~2km east.

Sand is naturally bypassing the structure but at a significantly reduced rate.

Geographe Bay beaches are highly responsive to blocking of alongshore sediment transport by structures.

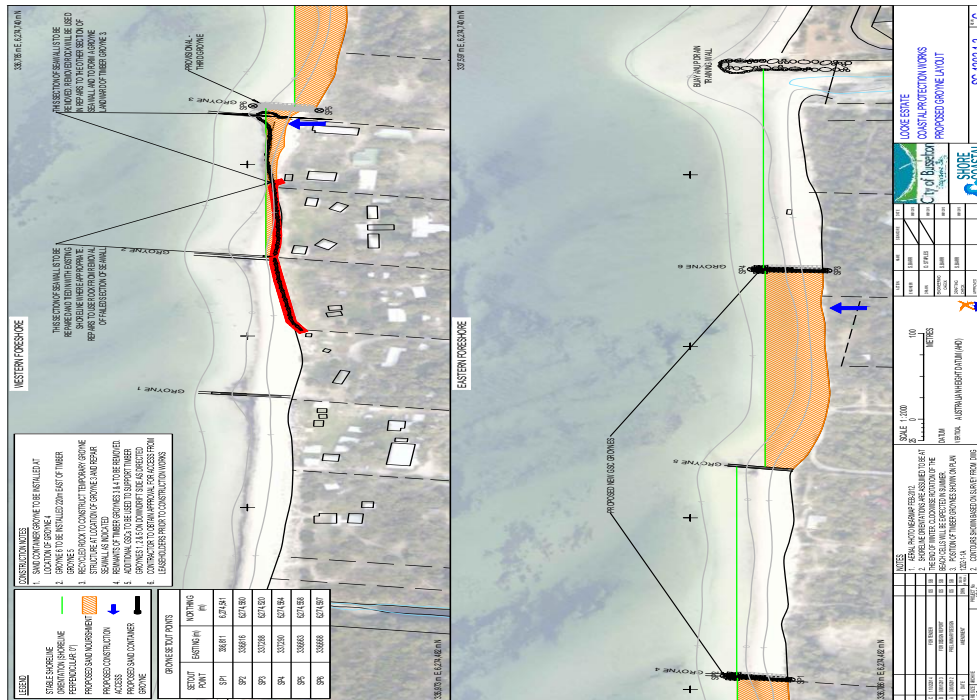
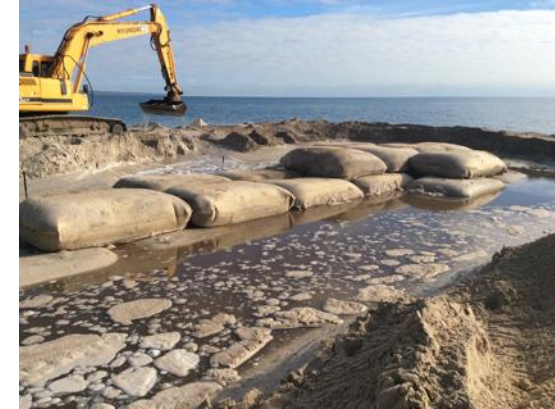
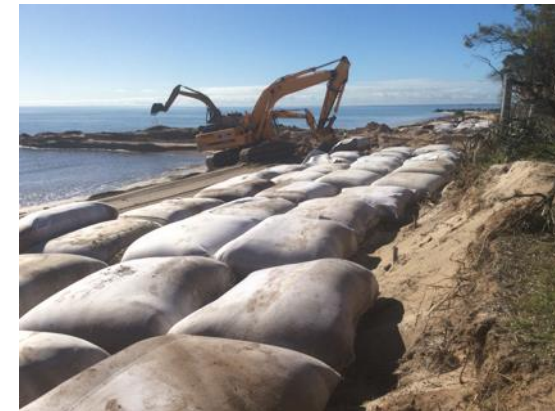
# Locke Estate Coastal Works - Phase 1 GSC Groynes (2014)

- Works completed in May/June 2014 by BCP.
- Three geotextile sand container (GSC) groynes & sand nourishment.
- Two structures (Groynes 3 & 4) replaced failed timber groynes.
- New structure at eastern end of campsites (Groyne 6).
- 5,000m<sup>3</sup> of sand from commercial sand pits placed on the beach to improve amenity and mitigate downdrift erosion.
- Removal of rock on beach (relocated to seawall).

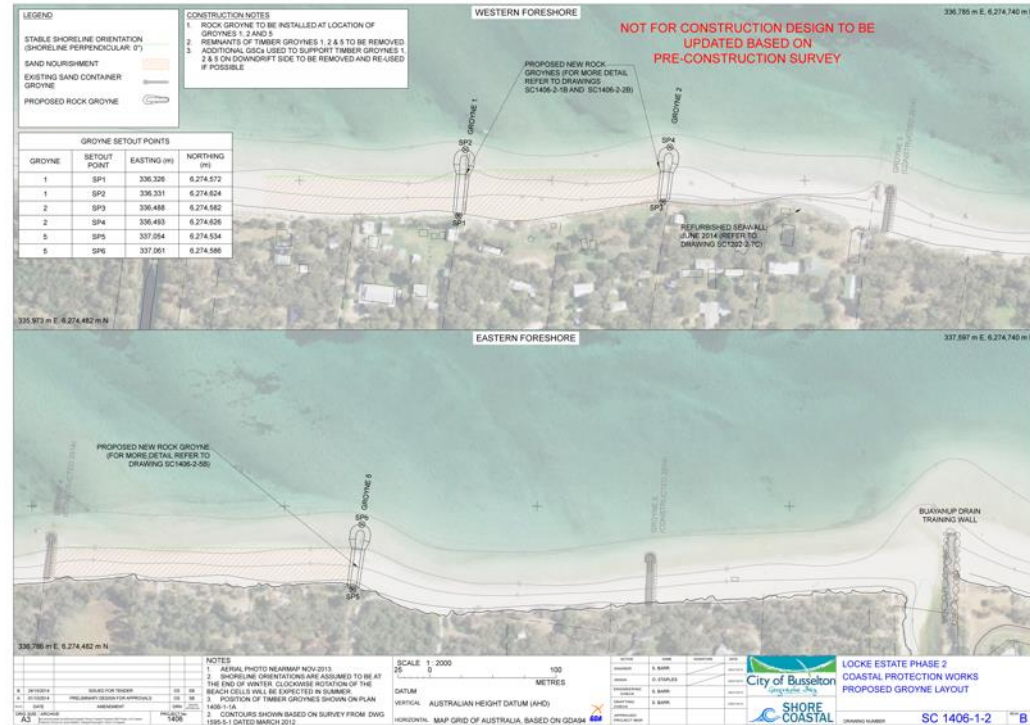
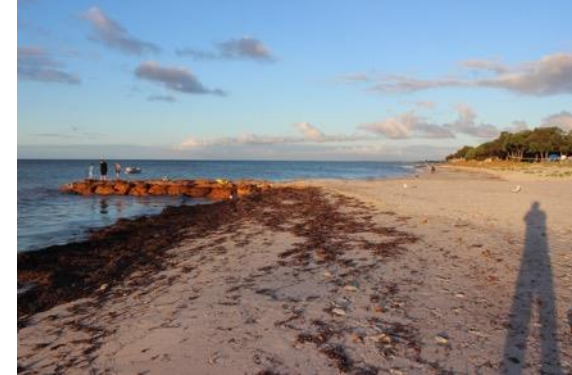
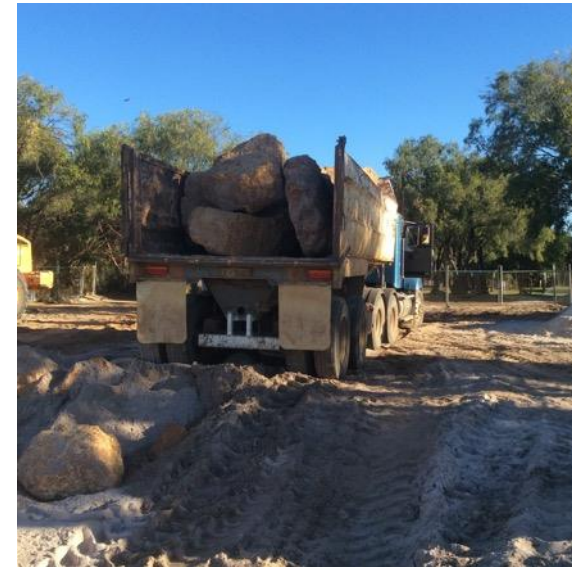
# Locke Estate Coastal Works - Phase 2 Rock Groynes (2015)

- Works completed by June 2015 by BCP.
- Three rock groynes (Groynes 1, 2 & 5) replacing timber groynes.
- Rock structures (durability) provide a balance with GSC structures (amenity).
- 7,500m<sup>3</sup> of sand from commercial sand pits placed on the beach to improve amenity and mitigate downdrift erosion.

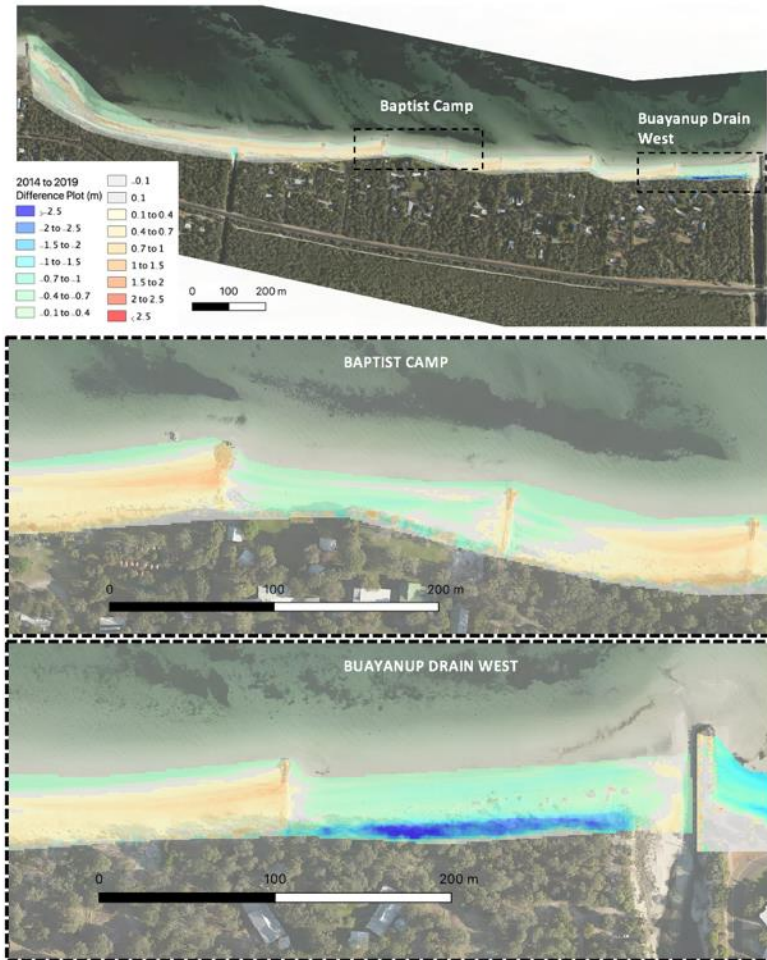
Figure 4.2 – Difference Plot from April 2014 to Dec 2019 at Locke Estate (above) and close up of the coast at the Baptist Camp (middle), and Buayanup Drain West (below).

- High rates of erosion observed in 1960s and 1970s mitigated by initial coastal protection works (timber groynes).
- Accreted erosion due to failure of timber groynes mitigation by 2014/15 works.
- Coastal area will continue to be affected by erosion for storms (relocation of structures).
- Local issues at Baptist Camp (seawall end erosion) and Legacy camp (downdrift) and Forth St.

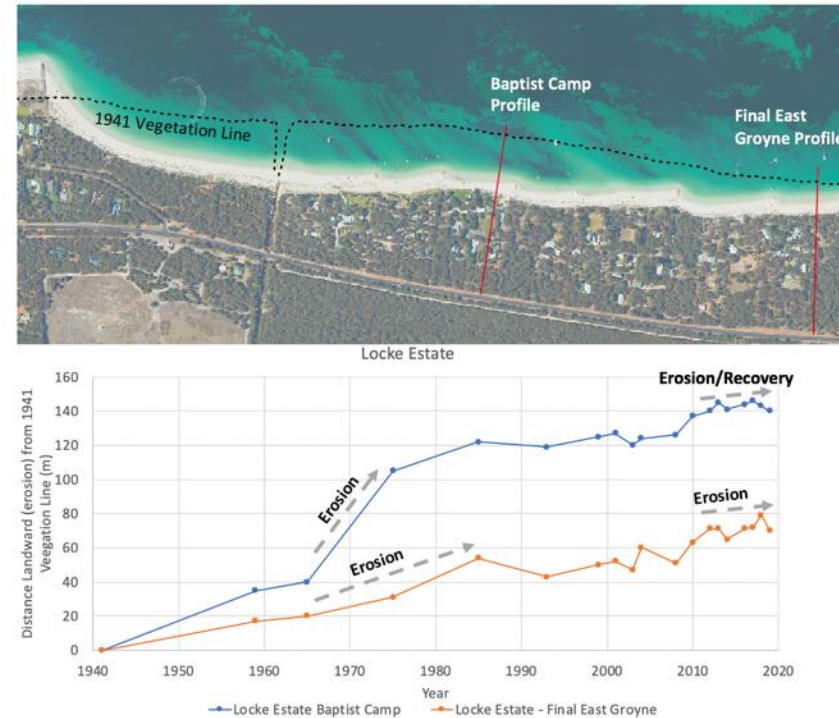
Figure 3.1 – Landward migration of the vegetation (erosion) since 1941 (below), measured at the two profiles (above).
