Lower Vasse River Waterway Management Plan

May 2019

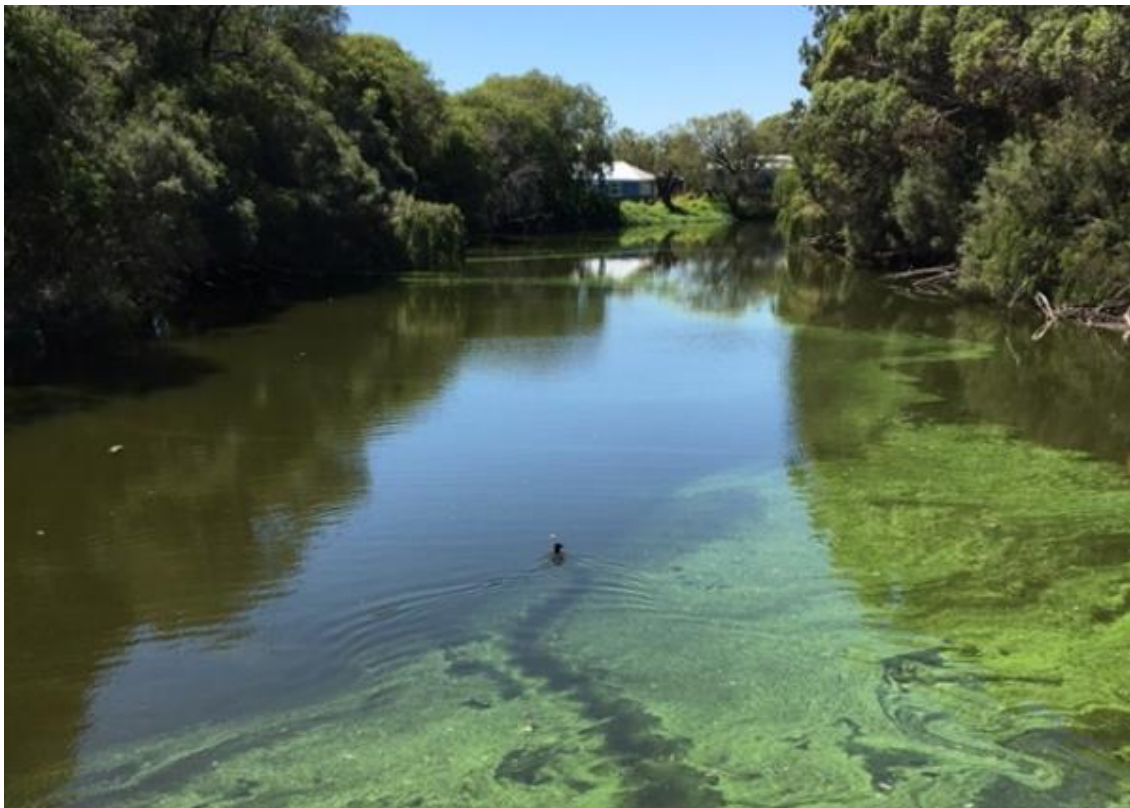
Figure 5. Blue green algal bloom in the Lower Vasse River.

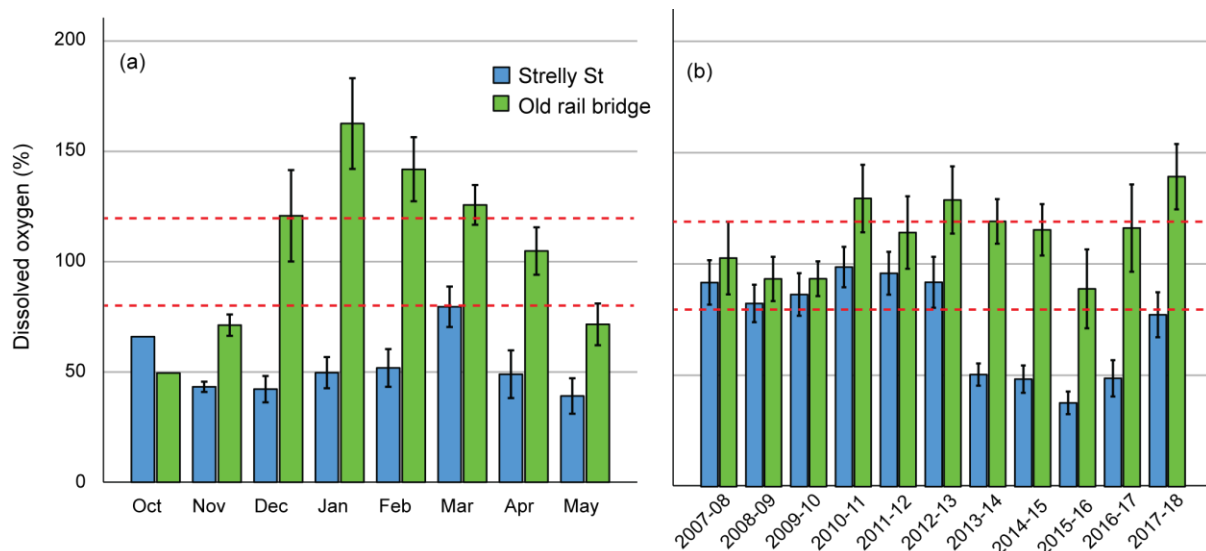
Figure 7. Dissolved oxygen concentrations in the Lower Vasse River: average monthly means for 2016-2018 centred around summer (a); and annual means since 2007-08 (spring-autumn sampling) (DWER 2018a).

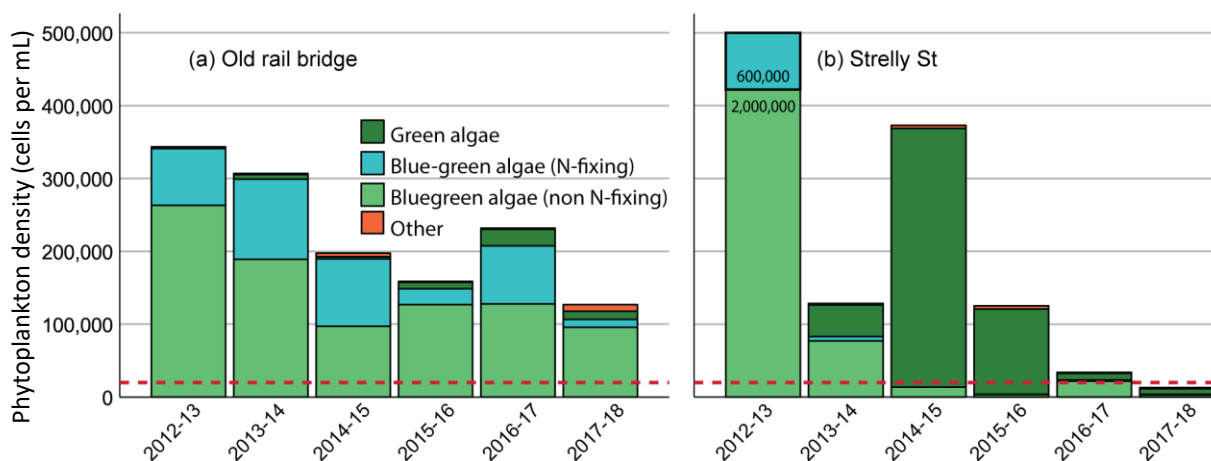
Figure 8. Mean cell densities for main phytoplankton species groups at sampling sites in the Lower Vasse River during spring-summer-autumn seasons since 2012 (DWER 2018b). Red dashed line is the guideline value of 20,000 cells per millilitre for recreational use.

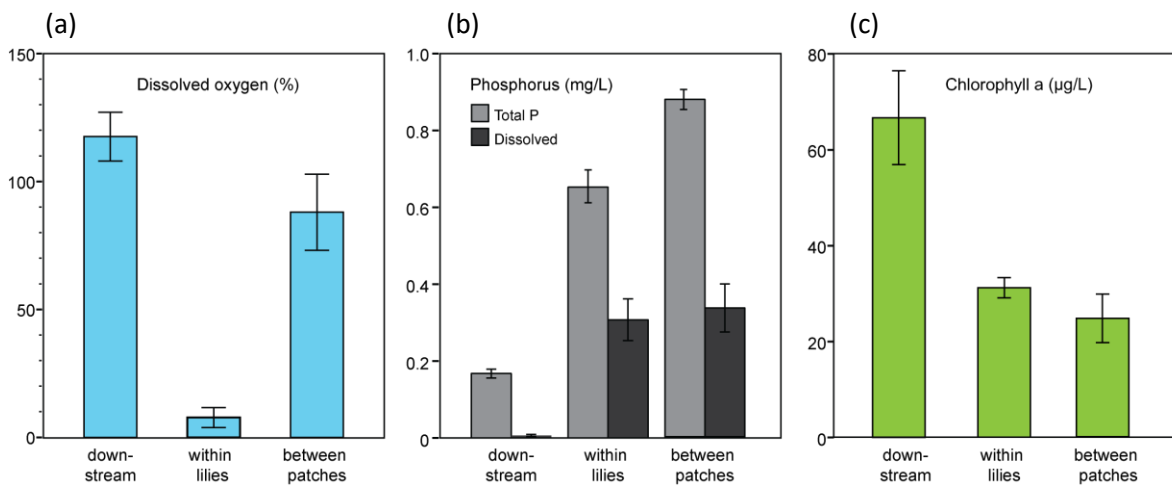
Figure 10. Comparison of water quality in relation to Mexican waterlily in the Lower Vasse River: downstream of the waterlily infestation, within dense waterlily growth, and in areas of open water between patches of waterlily (200-300m reaches) (Paice 2018).

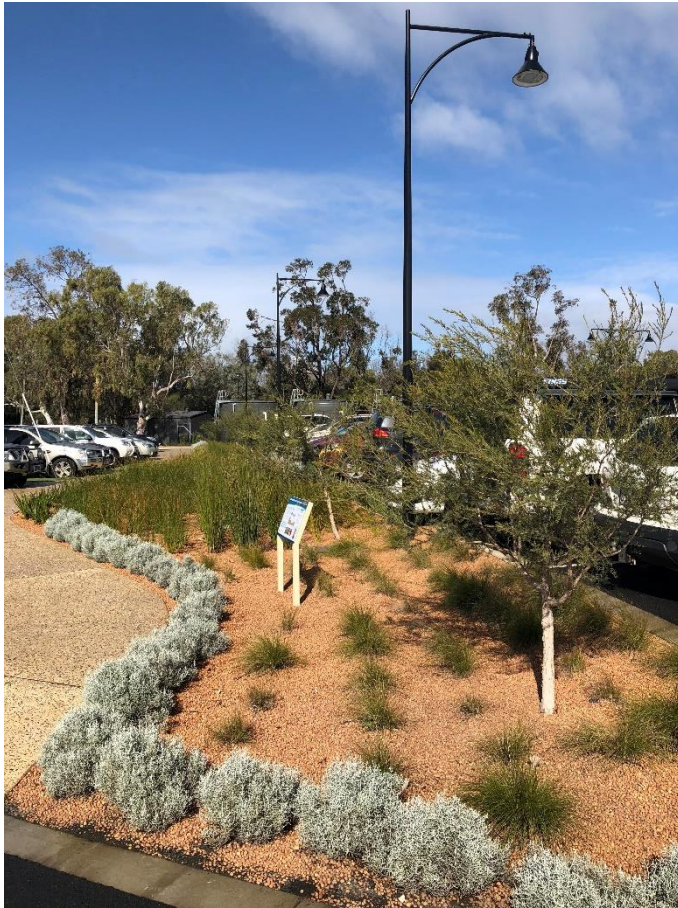
Figure 16. Example of a rain garden for stormwater quality management, at the City Administration building.

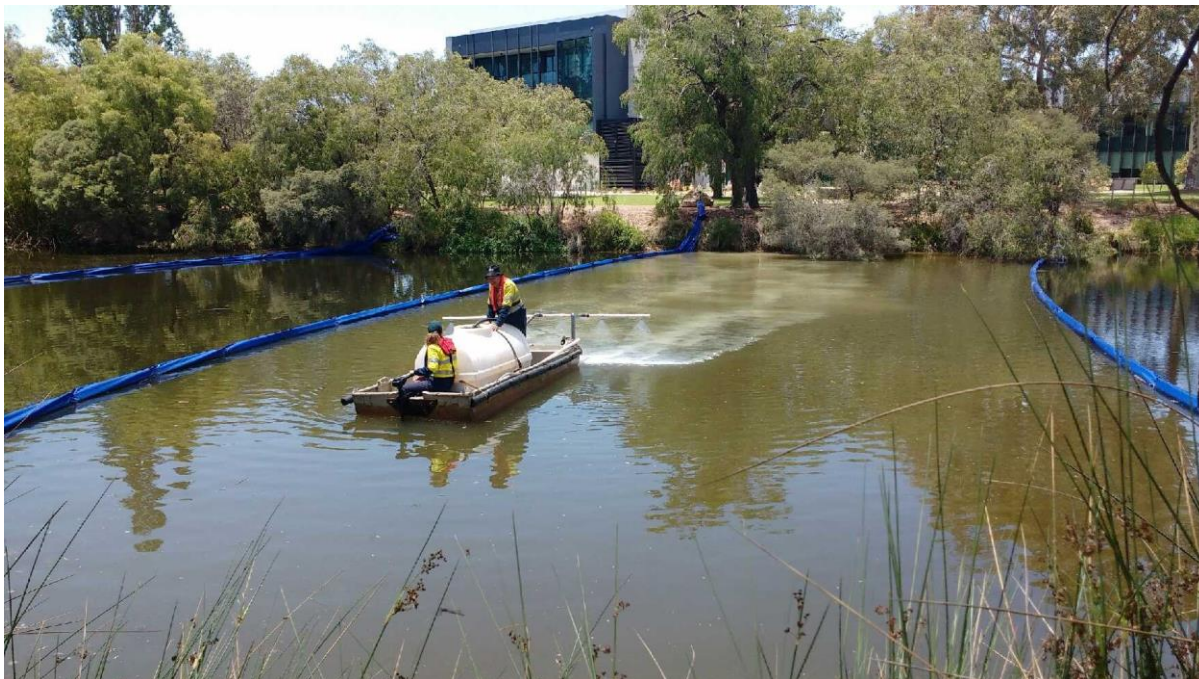
Figure 18. HT clay being applied in the Lower Vasse River during the 2017-18 trial.

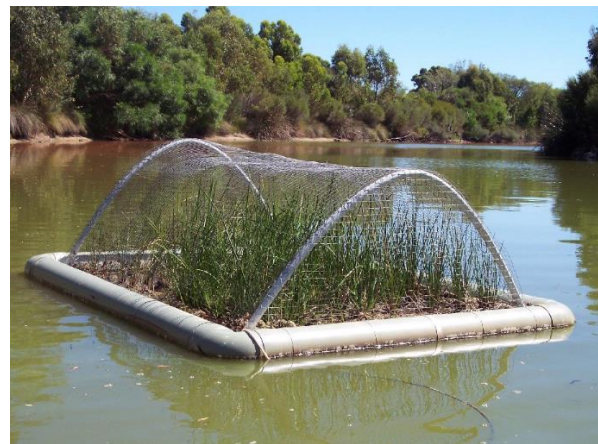
Figure 20. Floating island on the Lower Vasse River installed in 2002.

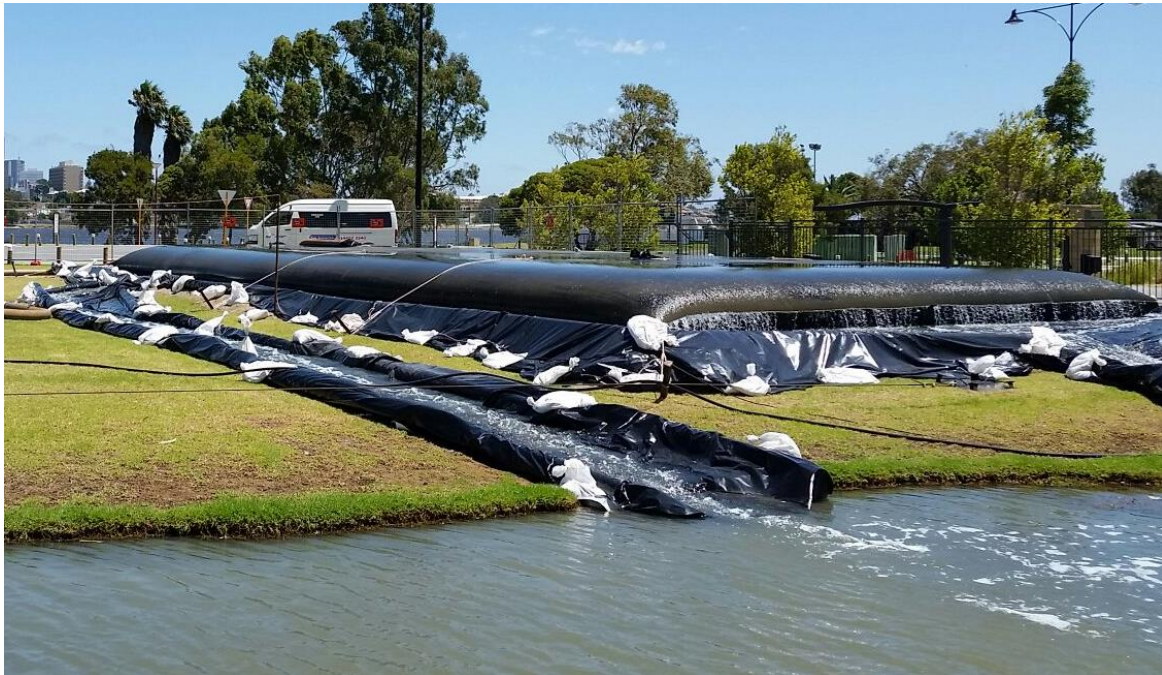
Figure 21. Geotextile bags used for sediment removal via dredging.
